City of Livermore

Potable Water System

Asset Management Plan

2016

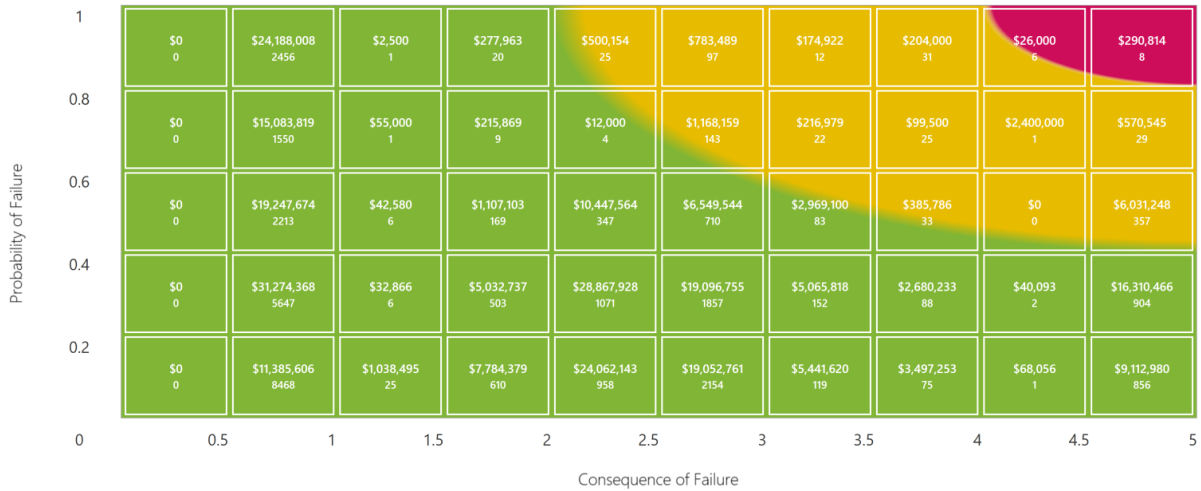
The following figure shows the risk results developed from the PoF and CoF scores. The matrix below shows the WRD asset risk scores categorized by low, medium, and high risk. The assets in the red zone of the risk matrix represent the assets with the highest likelihood and highest impact of failure.

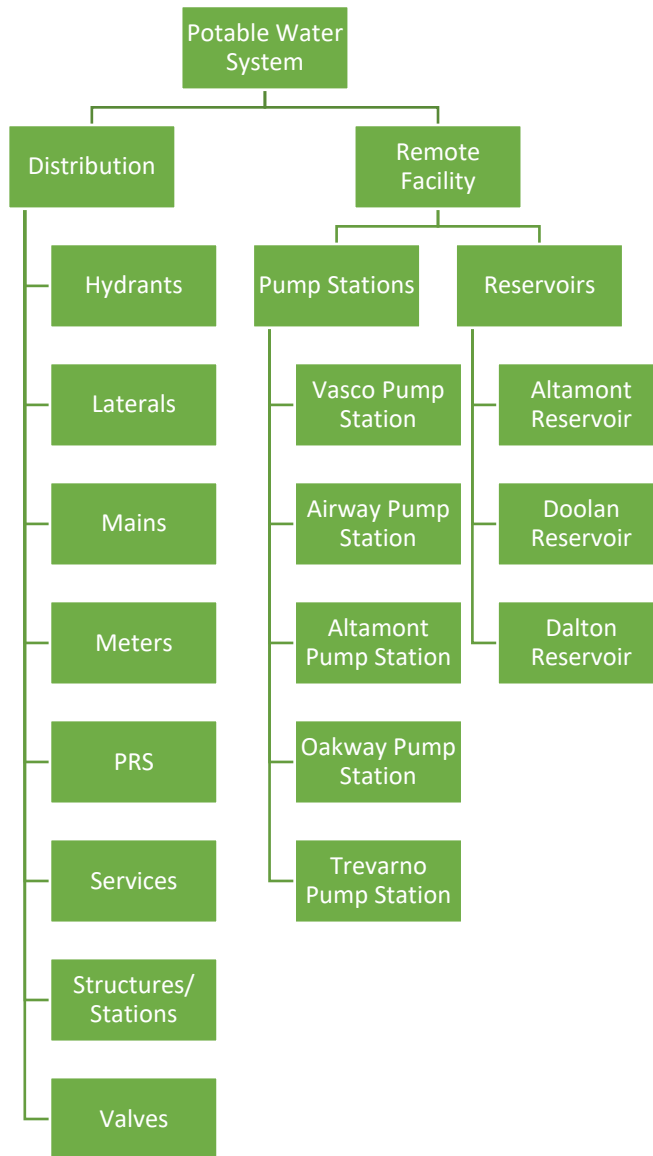
Figure 2-1 Potable Water System Asset Hierarchy

The asset hierarchy allows WRD to organize and easily navigate through its asset register. As shown in the figure, the potable water assets are organized by distribution assets and remote facility assets. The distribution assets are further organized into asset categories (e.g., hydrants, laterals, mains). The remote facility assets are further categorized into pump station and reservoir assets.

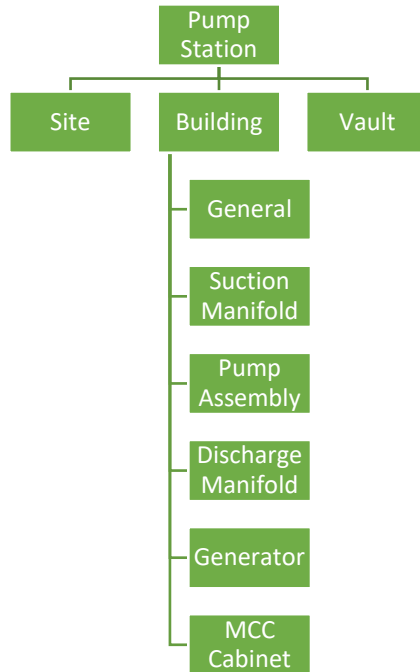
Figure 2-2 Pump Station Asset Hierarchy

General asset hierarchies for the pump stations and reservoirs are illustrated below.

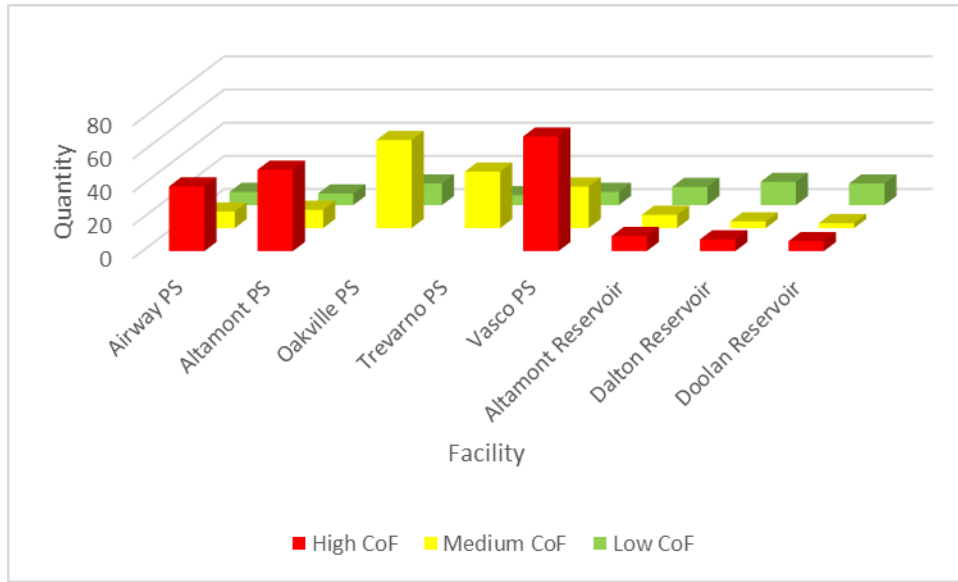
Figure 4-13 Remote Facility CoF Level by Quantity

The following graphs present the CoF scores for the remote facility assets. As shown in Figure 4-13, Airway, Altamont, and Vasco pump stations have high numbers of assets with high CoF (e.g., pumps, motors, valves). Trevarno has no high CoF assets because the entire facility is a back-up station, and the overall facility criticality is lower than the other pump stations. All three of the reservoirs have a high number of high CoF assets. These assets also present a relatively high percentage of the total replacement cost of the reservoirs. The reservoir tanks represent most of the high CoF asset replacement costs.

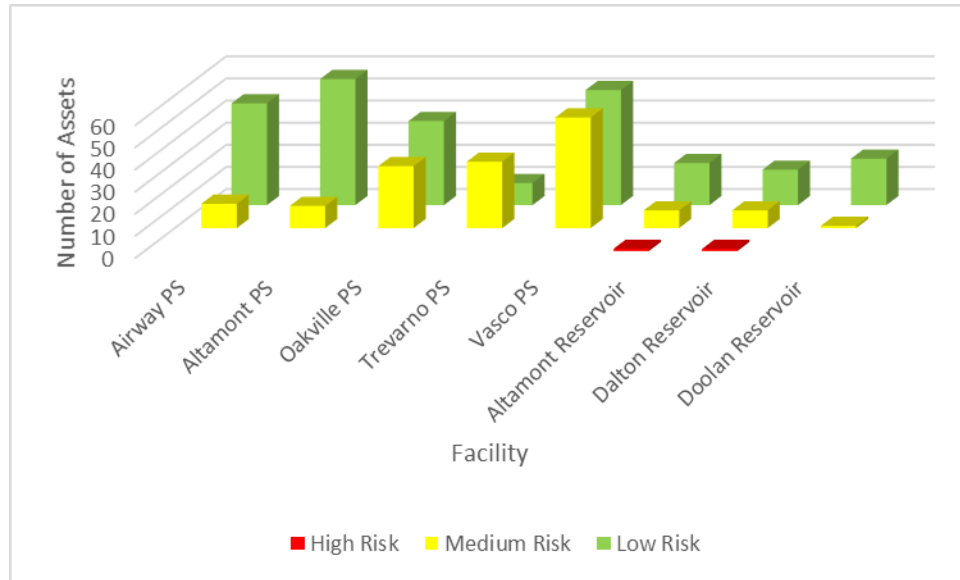
Figure 4-22 Remote Facility Risk Level by Quantity

The figures below show the risk profiles for the potable water remote facilities assets. Of the remote facilities, only Altamont and Dalton Reservoirs have high risk assets. As shown in Figure 4-24, these assets make up a very small portion of the replacement cost of the entire site.
